ACCIDENT

Aircraft Type and Registration:	Boeing 737-800, EI-DLV
No & Type of Engines:	2 CFM56-7B26 turbofan engines
Year of Manufacture:	2006 (Serial no: 33,598)
Date & Time (UTC):	15 September 2017 at 0807 hrs
Location:	London Stansted Airport
Type of Flight:	Commercial Air Transport (Passenger)
Persons on Board:	Crew - 6 Passengers - 184
Injuries:	Crew - None Passengers - None
Nature of Damage:	Failure of left nose landing gear axle and separation of left nosewheel
Commander's Licence:	Airline Transport Pilot's Licence
Commander's Age:	33 years
Commander's Flying Experience:	4,500 hours (of which 4,300 were on type) Last 90 days - 255 hours Last 28 days - 85 hours
Information Source:	AAIB Field Investigation

Synopsis

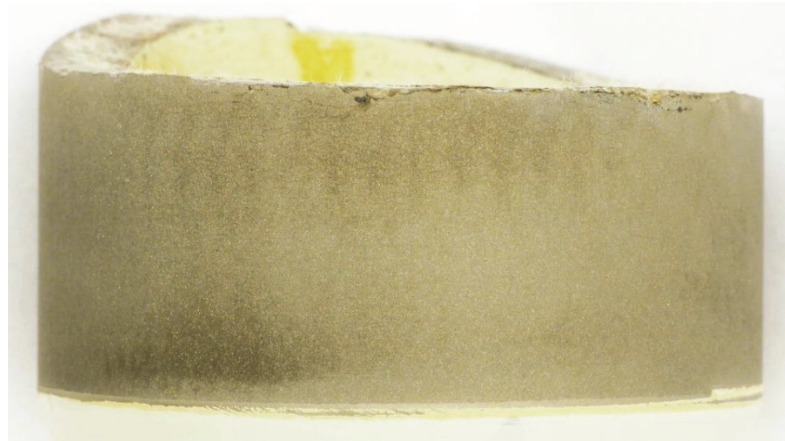
Figure 5

An examination of the wheel bearings showed that they were in good condition and rotated freely indicating that bearing deterioration did not contribute to the heating of the axle bearing journals. The bearing covers about half the width of the axle bearing journal and yet the heat damage expanded nearly the entire width of the journal. Given this information, the aircraft manufacturer concluded that the only explanation for the base metal heat damage was that it had occurred during post-plating grinding.

Lower face of the failed axle after chrome removal.
The dark areas are evidence of heat damage

When the base metal becomes overtempered from abusive grinding, there is a softening of the material and its strength reduces. The heating also causes a significant change in residual stress from compressive stresses on the surface to tensile stresses which increase the part's susceptibility to cracking. During an abusive grinding event there is rapid localised heating followed by rapid cooling which results in thermal strain that can cause heat-induced cracking. During subsequent cadmium plating of other parts of the inner cylinder, hydrogen can diffuse into areas of tensile stress causing hydrogen embrittlement cracking. This can occur during the period between the cadmium plating and the stress relief bake which removes the hydrogen. These cracks can then propagate in service due to SCC or fatigue or both.

To ensure that any abusive grinding is detected, the MRO of EI-DLV has introduced a new process to perform a Barkhausen inspection on all journals after grinding. The MRO has also introduced a Barkhausen inspection early in the overhaul process, prior to the Nital etch test.
